Navajo Abandoned Uranium Mine

Site Screen Report

Mine Name: **Lemuel Littleman No. 2**Mine ID: **127**

August 2011

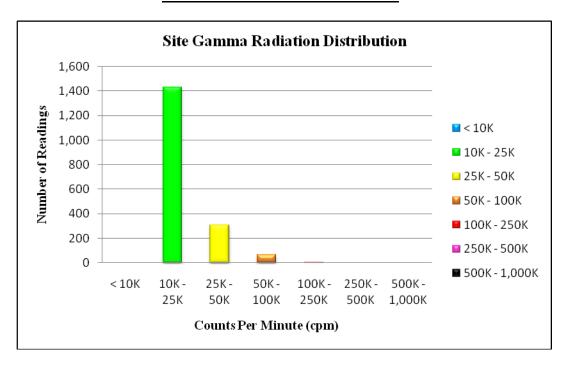
Site Gamma Radiation Statistics				
Number of Readings	1,809			
Minimum (cpm)	13,668			
Maximum (cpm)	145,594			
Mean (cpm)	22,847			
Median (cpm)	18,723			
Standard Deviation	11,301

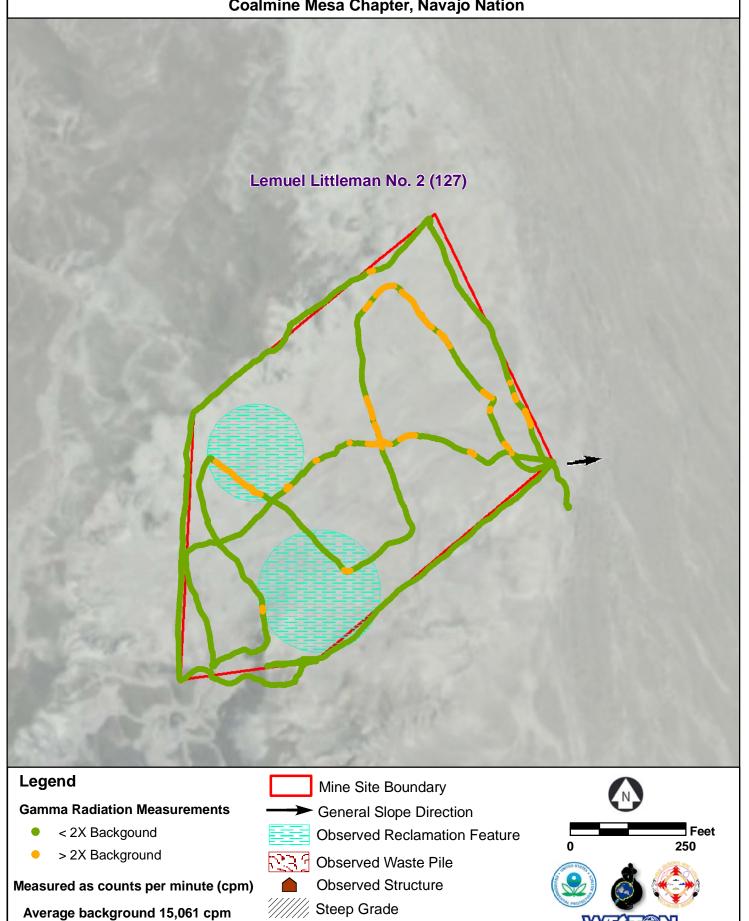
Figure 1 - Gamma Radiation Measurements, Above Two Times Background
Lemuel Littleman No. 2 (127)
Coalmine Mesa Chapter, Navajo Nation

A total of 1,809 gamma radiation measurements were collected from the mine site, ranging from 13,668 cpm to 145,594 cpm. The measurements are represented in Figures 1 and 2.
